TECHNICAL REPORT GL-79-14

SUSCEPTIBILITY OF DISPERSIVE CLAY AT GRENADA DAM, MISSISSIPPI, TO PIPING AND RAINFALL EROSION

Edward B. Perry

September 1979

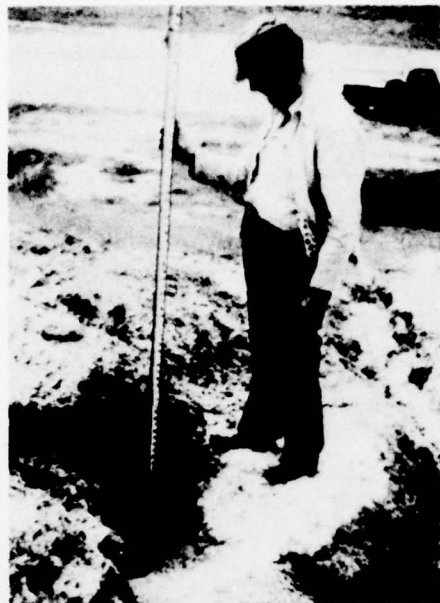
a. View downstream showing tunnel entrance

Figure 11. Photograph of rainfall erosion tunnel,
30 January 1976

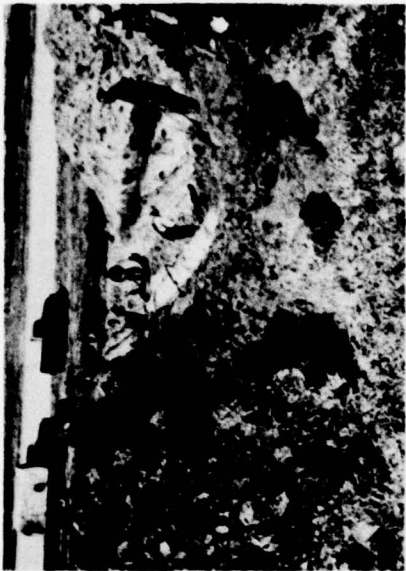
b. Backfilling around slope drain pipe sta 106+00, 19 March 1956

Figure 17. Repairing rainfall erosion tunnels, 19-28 March 1956
(from File 1514-02 Subsurface Erosion, Vicksburg District)

Figure 17 shows the repair measures that were carried out from March to June 1956 to ready the dam for dedication on 25 July 1956.

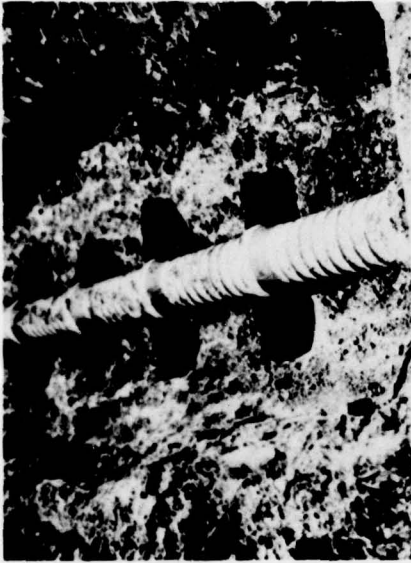
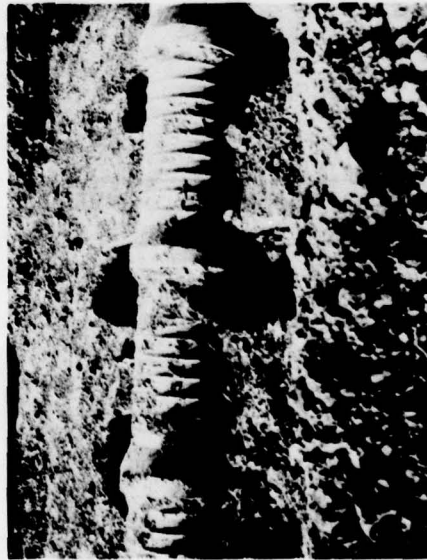
a. Excavation around concrete slope drain pipe and drop inlet

b. Close-up top view of excavation

c. Close-up side view of excavation

Figure 20. Repairing rainfall erosion tunnels at sta 118+00, 9 June 1958 (from File 1514-02 Subsurface Erosion, Vicksburg District)

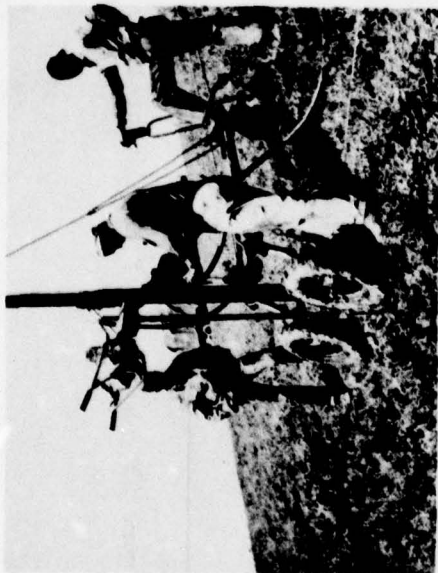
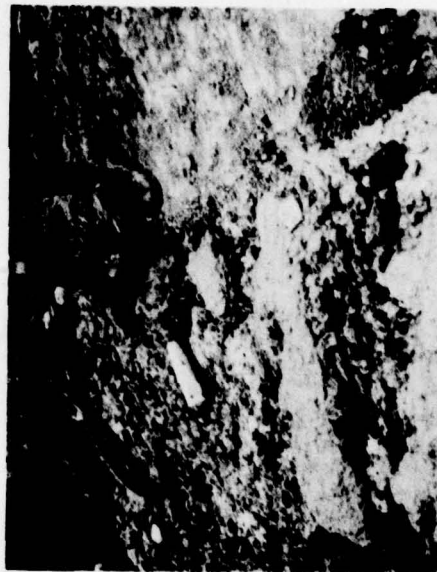
a. Predrilling holes for grouting,
13 May 1960

b. Obtaining samples of grout mixture,
13 May 1960

c. Grouting with mud-jacking machine,
24 May 1960

d. Close-up view of grouting,
10 May 1960

Figure 24. Experimental curtain wall grouting, 10-24 May 1956 (from Reference 13)

23. During May and June 1960, the second experimental method of preventing rainfall erosion tunnels was conducted. Following a suggestion made by the Greenwood Area Office in February 1956, it was decided to place barriers to the flow of water in the horizontal erosion tunnels.²⁷ One 400-ft section of the downstream slope was modified by curtain wall grouting between sta 120+00 and 124+00 and one 800-ft section by clay-filled trenches between sta 124+00 and 132+00 with locations shown in Figure 23. Curtain wall grouting was conducted by drilling 13 parallel lines about 20 ft apart of 2-in.-diam by 6-ft-deep holes on 18-in. centers placed longitudinally along the downstream slope of the dam between the crown and the toe (Figure 24). A grout mixture of silt with 7.5 percent granular bentonite by volume was used with the end of the grout pipe near the bottom of the hole and top of the hole plugged for about 1 ft by an enlarged section of the pipe. Granular bentonite was used in the grout mixture for its ability to swell later when surface drainage seeped into the horizontal erosion tunnels. The silt and bentonite were premixed in a small concrete mixer before being placed in the hopper of the mud-jacking machine where the minimum amount of water was added to produce a grout that was pumpable. Seven 19-in.-wide by 5-ft-deep trenches were dug with a machine approximately 35 ft apart longitudinally along the downstream slope of the dam between the crown and the toe (Figure 25). The trenches were backfilled with a lean clay (CL) and compacted in about 4-in.-thick compaction lifts using pneumatic tampers.¹³ Prior to the curtain wall grouting and clay-filled trenching

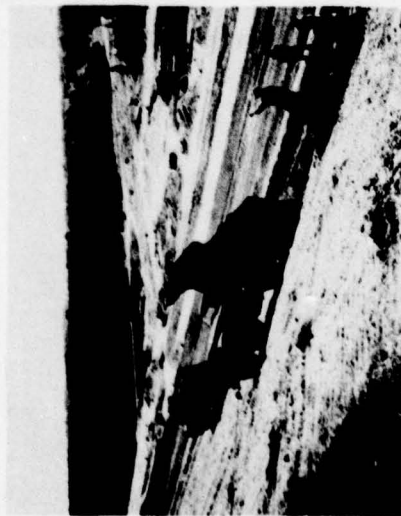
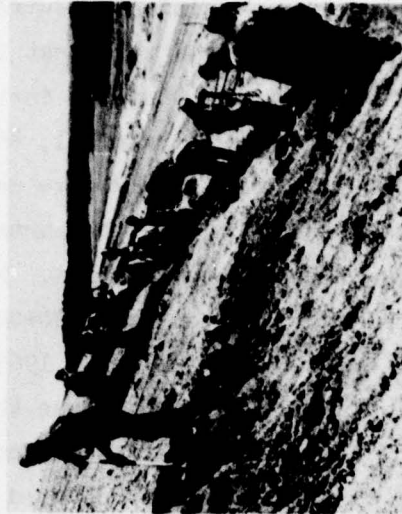
a. Opening trench, 10 May 1960

c. Placing clay backfill in trench, 13 May 1960

d. Compacting backfill with pneumatic tampers, 13 May 1960

Figure 25. Experimental clay-filled trenches, 10-13 May 1960 (from Reference 13)

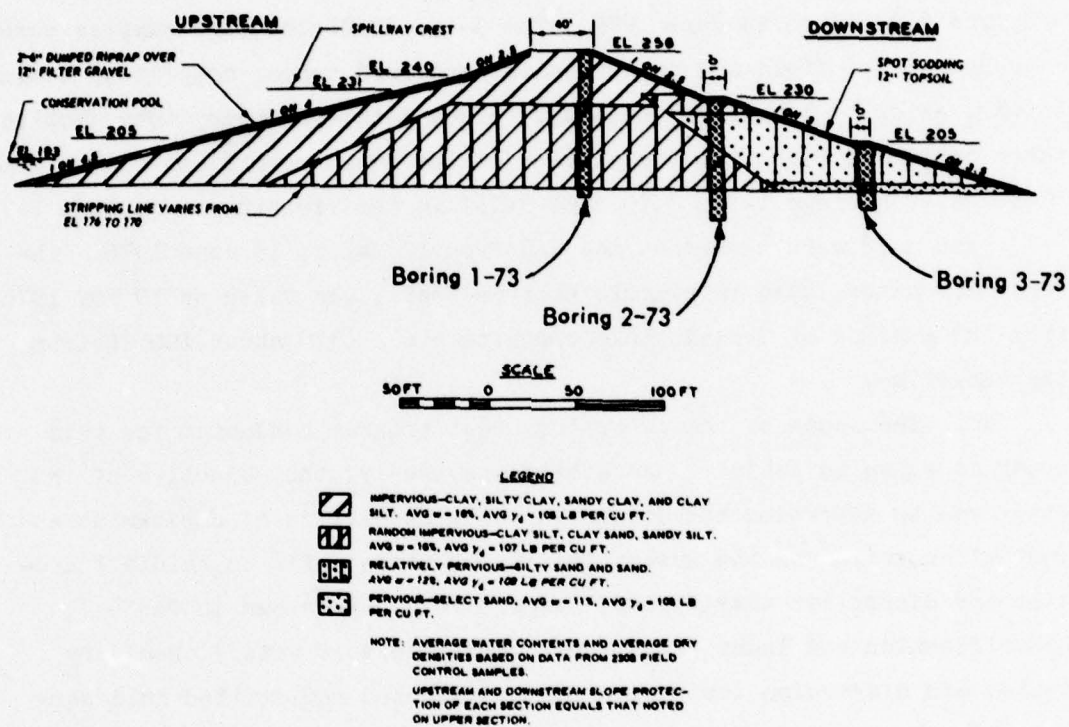
39. Undisturbed soil samples taken by the Vicksburg District from 30 January to February 1973 from borings 1-73, 2-73, and 3-73 (Figure 36) from the downstream slope of Grenada Dam at sta 136+10, offset 16, 94, and 186 ft right of the center line, respectively, were tested at the WES from 6 April to 24 June 1976. The 5-in.-ID Shelby tube samples were extruded in the field and preserved in cardboard tubes, completely sealed in wax, prior to laboratory testing. Also, 3-in.-ID Shelby tube samples taken on 10 May 1976 from the surface of the downstream slope of the dam (designated borings 1-76, 2-76, and 3-76) in the vicinity of borings 1-73, 2-73, and 3-73 were tested at the WES from 12 May to 16 June 1976. The reservoir water, used in pinhole erosion tests, was taken on 10 May 1976 from the surface of Grenada Lake opposite sta 136+10 about 100 ft from the shoreline.

Figure 36. Location of borings 1-73, 2-73, and 3-73 at sta 136+10 (adapted from Reference 3)

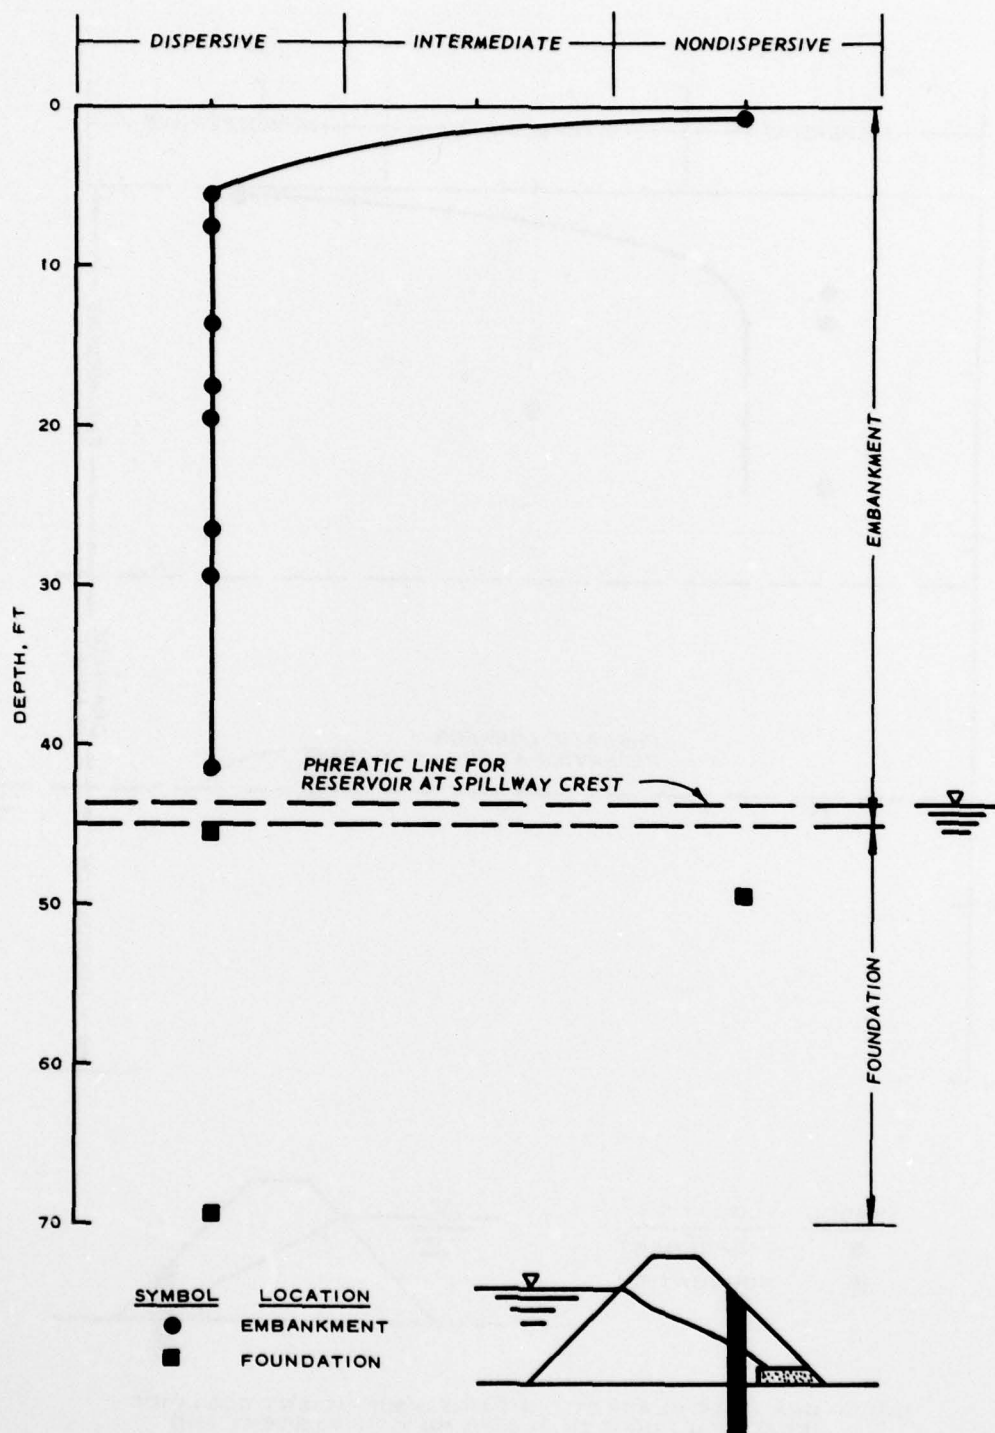
48. A summary of the dispersion tests is shown on Table 17. Using the consensus of the SCS dispersion test results, soil pore water chemistry correlation, and pinhole erosion test results, a summary of dispersion versus depth for borings 1-73 and 1-76, 2-73 and 2-76, and 3-73 and 3-76 are shown in Figures 55-57, respectively. The embankment soil is nondispersive at the surface and dispersive below a depth of about 6 ft. Based upon the limited data obtained below the embankment, the foundation soil is dispersive at the surface and nondispersive to dispersive with depth.

Figure 56. Summary of dispersion versus depth for borings 2-73 and 2-76

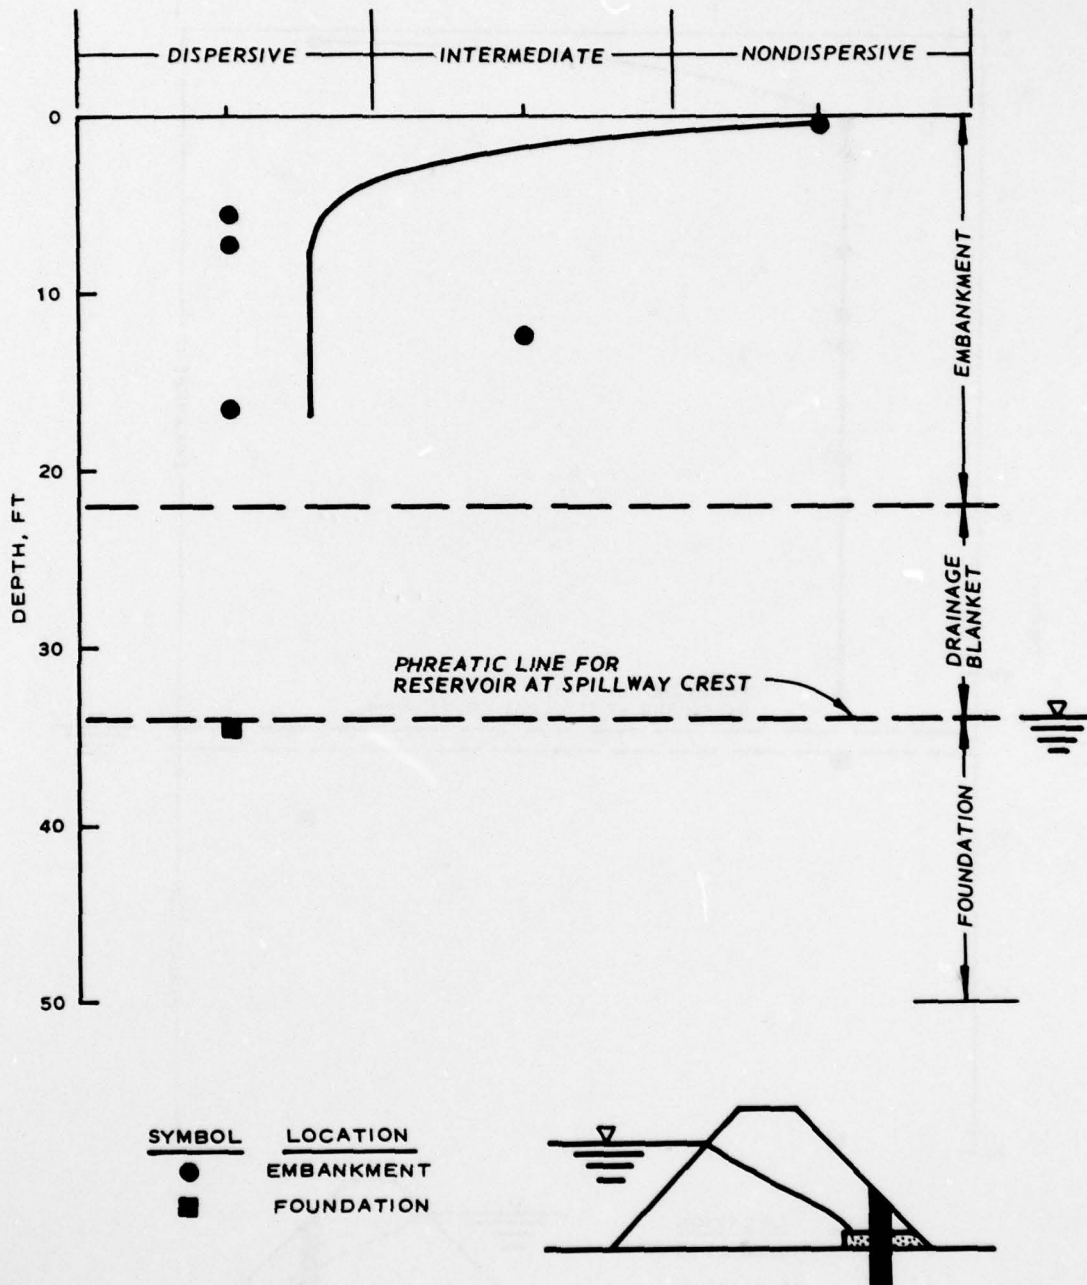
NOTE: DRAINAGE BLANKET CONTAINS INSUFFICIENT COLLOIDS (FRACTION FINER THAN 0.005 MM \leq 12 PERCENT AND PLASTICITY INDEX \leq 4) TO SUPPORT DISPERSIVE EROSION

Figure 57. Summary of dispersion versus depth for borings 3-73 and 3-76

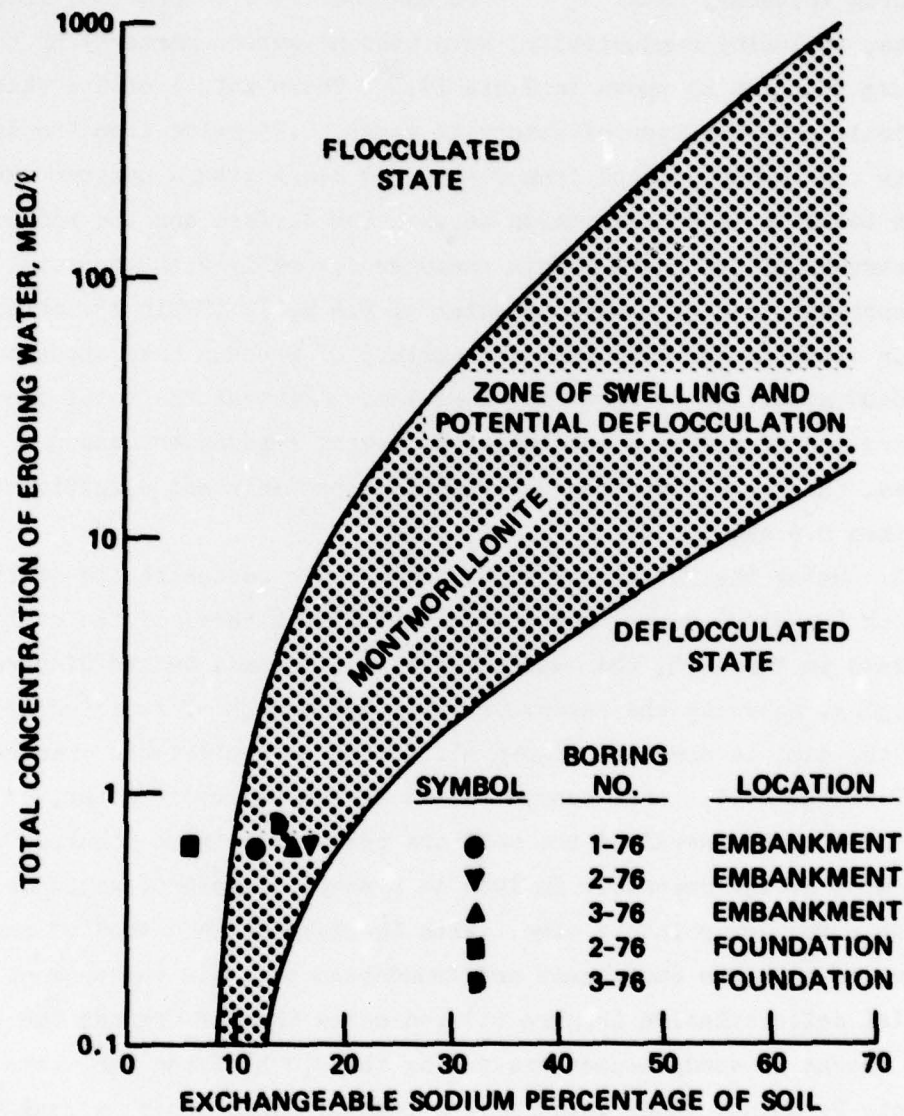
53. Using the ESP of the soil, total ionic concentration of the reservoir (eroding) water, and predominate clay mineral of the soil summarized in Table 20, the susceptibility of Grenada Dam to dispersive clay piping, assuming the reservoir water has a path of rapid access across the dam, is shown in Figure 61. Since no appreciable changes in the ESP of the soil, total concentration of the reservoir water, or predominate clay mineral of the soil are believed to have occurred from impoundment of the reservoir in 1954 to present, Figure 61 would be applicable for any point in time. With the Australian method of analysis, the plot of both the embankment and foundation soils in the zone of potential deflocculation (Figure 61) indicates that if Grenada Dam contained cracks or sandy lenses traversing the width of the dam where the reservoir (eroding) water would have a path of rapid access across the dam, there would be a potential for dispersive clay piping. Since piping failure through the embankment or foundation has not occurred at Grenada Dam, either the dam is free from cracks or sandy lenses traversing the width of the dam, or if cracks are present, the soil is able to swell and seal the flow channels.

Figure 61. Prediction of piping failure using the total ionic concentration of the eroding water and the ESP of the soil assuming the reservoir water has a path of rapid access across the dam (adapted from Reference 45 with the permission of the Publishers Butterworth, Sydney)
